### **Lessons Learned for the Tensiometer Probe Design**

**Author: Blair Grover**

**Data and Charts from Lower Sensor Field Validation:  
DU-10-TI, 2 and 3**

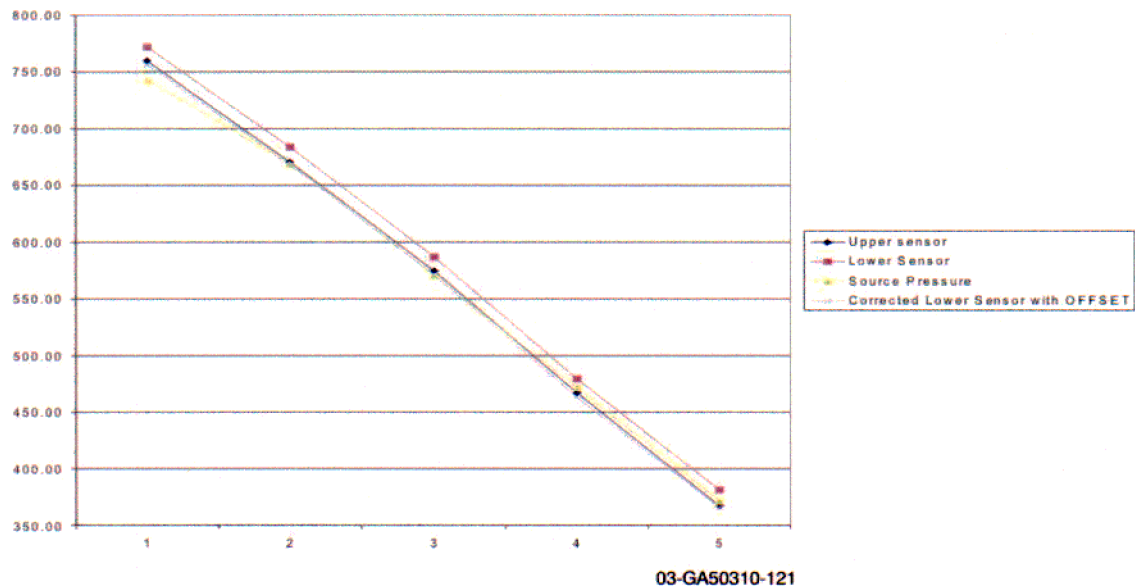
DU-10-T1

This unit does not have much water left in it. It needs to be refilled from ground surface.
